REUBEN HART RESERVOIR DAM

CT 00096

PHASE I INSPECTION REPORT
NATIONAL DAM INSPECTION PROGRAM

Identification No.: CT 00096
Name of Dam: Reuben Hart Reservoir Dam
City: Torrington
County and State: Litchfield, Connecticut
Stream: Hart Brook
Date of Inspection: 24 October 1978

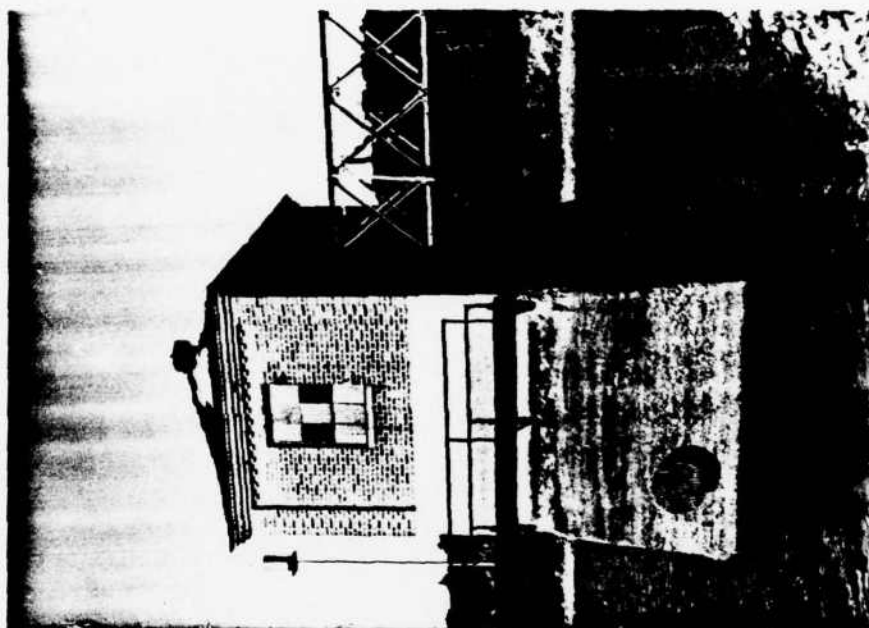
The intake tower is a concrete wet well shaft with three selective level inlet pipes controlled by slide gates (Appendix C, Photo No. 6). Two 18 in. dia. outlet pipes and a 6 in. dia. waste pipe are connected to the tower at approximately original ground level. A brick gatehouse contains the manual gate controls and is connected to the crest of the dam by a bridge. The concrete is in fair condition with some minor cracks and spalling noted. A portion of the roofing requires repair. The gates were not operated during the inspection, but according to Water Company staff all of them are serviceable.

Concrete tower shows some spalling and minor cracking. Roof shingles missing on right side.

6. Outlet tower and gate house.

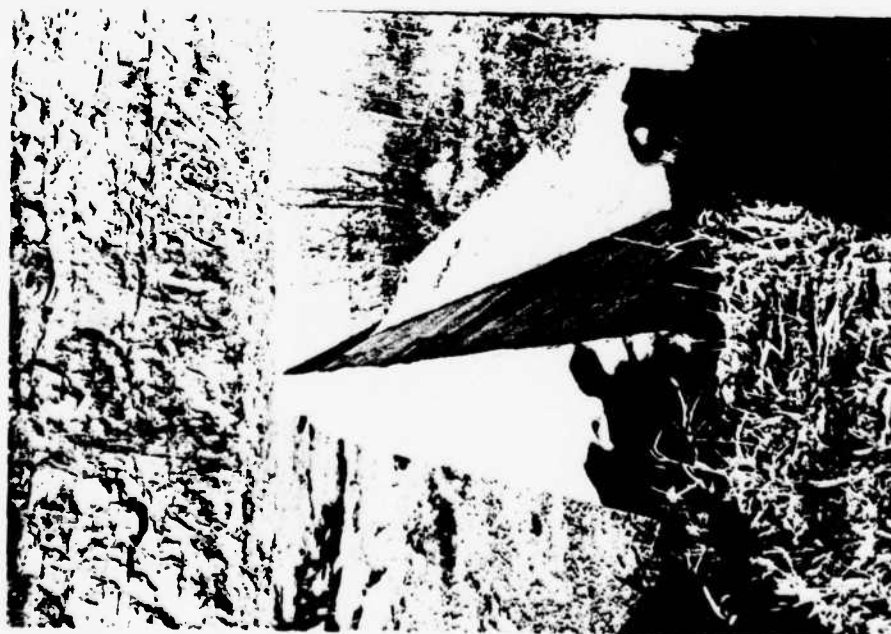
The present auxiliary spillway channel was originally the main spillway channel when the dam was first built. At the weir this channel is also in bedrock, but some distance below the weir it was excavated in earth and riprapped. The riprap has evidently not been maintained recently. The auxiliary spillway weir is in good condition (Appendix C, Photo No. 5).

5. Auxiliary spillway from left
end of embankment.
